# Manhole Inspection Summary

Manhole # S19GG\_022MH

Insp Date: **6/14/07 9:16 AM**

**Location** Address: **1500 APPLETON-MONROE**

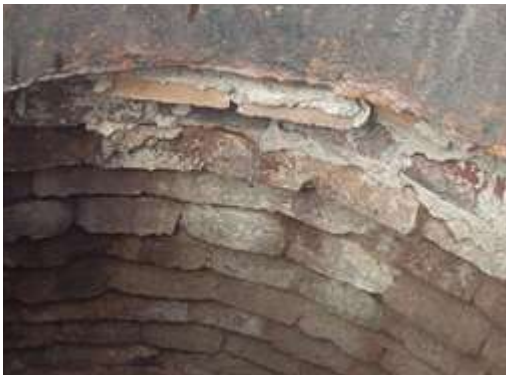
Defect 4

Condition: ☐ Sound ☐ Cracked ☐ Root Intrusion ☒ **Loose Brick** ☐ Deteriorated

LOOSE CHIMNEY BRICKS

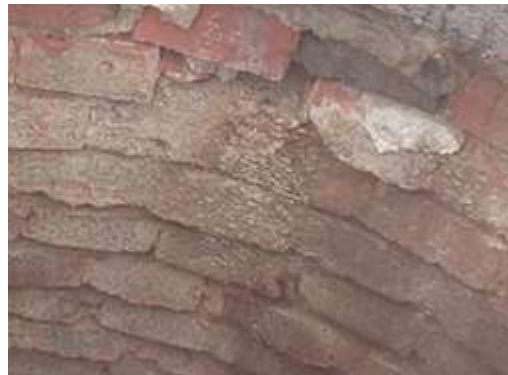
Defect 2

Condition: ☐ Sound ☐ Cracked ☐ Root Intrusion ☐ Loose Brick ☒ **Deteriorated**

DETERIORATION OF CORBEL

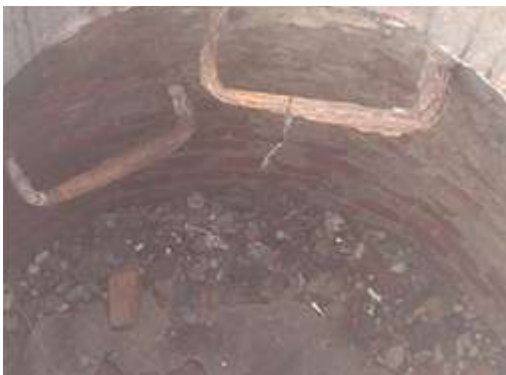
Defect 1

Count: **2** Missing: **0** ☒ **Corroded**

CORRODED STEPS

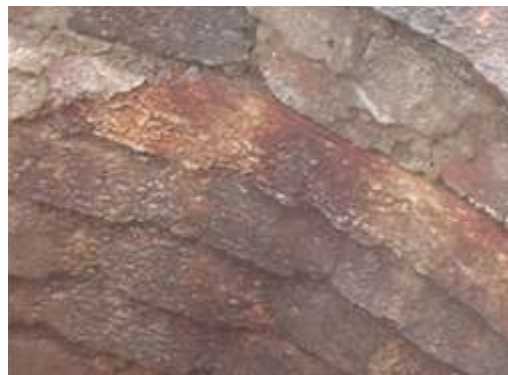
Defect 3

Infiltration: ☐ None ☒ **Joint** ☐ Cracks ☐ Mortar ☐ Roots ☐ Wall

INFILTRATION OF CORBEL

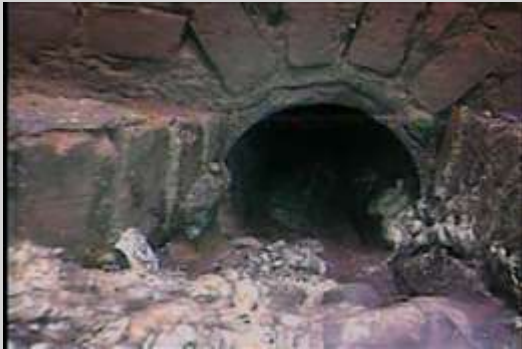
12 O'Clock Outflow

Pipe Height: **8.4** (in.) Rod and Bar (Angled)  
Pipe Material: **Clay** ☐ Pipe Lined  
Invert Depth: **6.43** (ft.) Flow Characteristics: **Slow**  
Deposits: ☐ None ☐ Mud ☐ Sludge ☒ **Debris** ☒ **Grease**  
Silt Depth: **2** (in.) Deposits Extent: **Medium**  
Infiltration: **None** Pipe Seal Cond: **Broken**

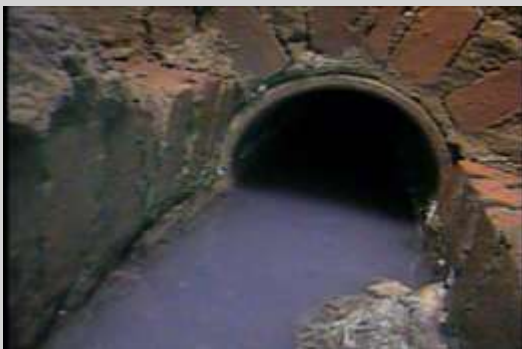
6 O'Clock Inflow

Pipe Height: **8.4** (in.) Rod and Bar (Angled)  
Pipe Material: **Clay** ☐ Pipe Lined  
Invert Depth: **6.22** (ft.) Flow Characteristics: **Slow**  
Deposits: ☐ None ☐ Mud ☐ Sludge ☒ **Debris** ☐ Grease  
Silt Depth: **2** (in.) Deposits Extent: **Light**  
Infiltration: **None** Pipe Seal Cond: **Sound**

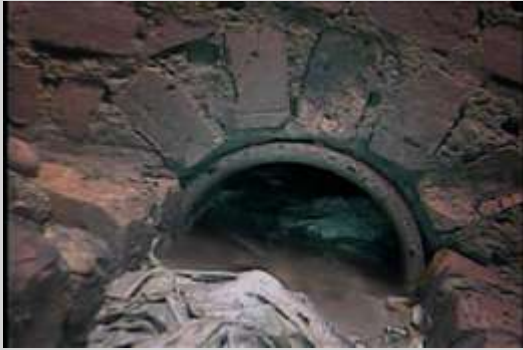
9 O'Clock Inflow

Deposits: ☐ None ☐ Mud ☐ Sludge ☒ **Debris** ☐ Grease

Silt Depth: **4** (in.) Deposits Extent: **Heavy**
